City of Chicopee

RE: City Council Minutes from the May 27, 2016 Special Meeting

Dietz and Company Architects, Inc. is pleased to present this Historic Structure Report (HSR) and the results of the team's efforts to document the history and physical condition of Chicopee City Hall. The overall purpose of any Historic Structure Report is to guide future rehabilitation, restoration, and preservation work for the subject structure. The 'Historical Information' section documents the history of the building and its changes over time. The 'System Description and Observations' portion of the report summarizes the survey, analysis and recommendations for the building.

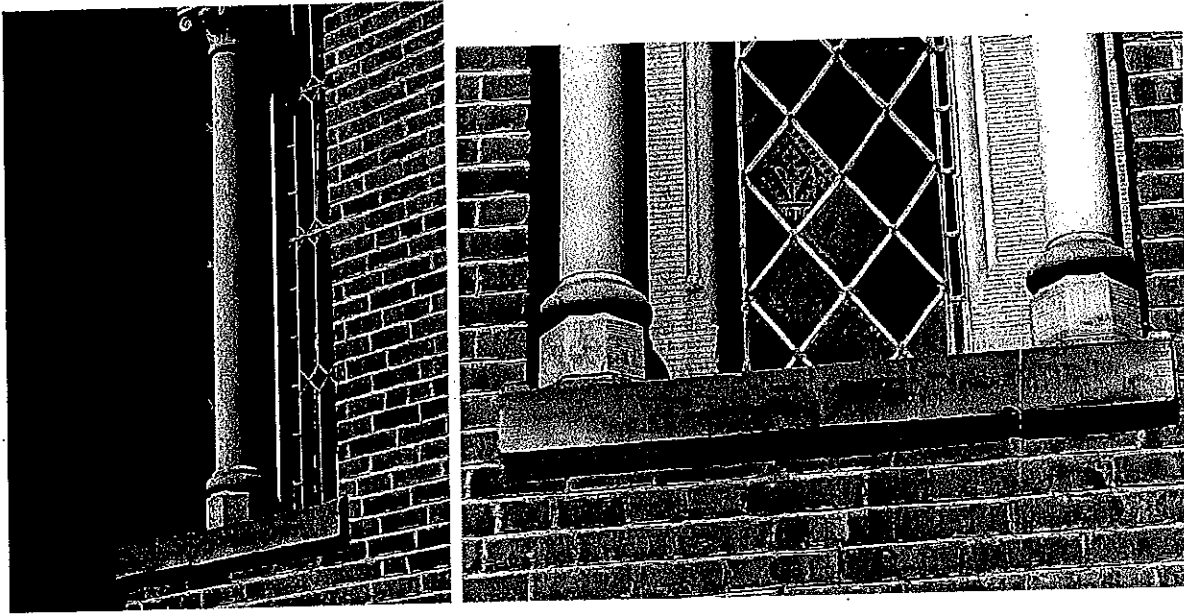
38. Photos 38a and 38b – Views of the cracked window sills on the gabled elevation of the South elevation.

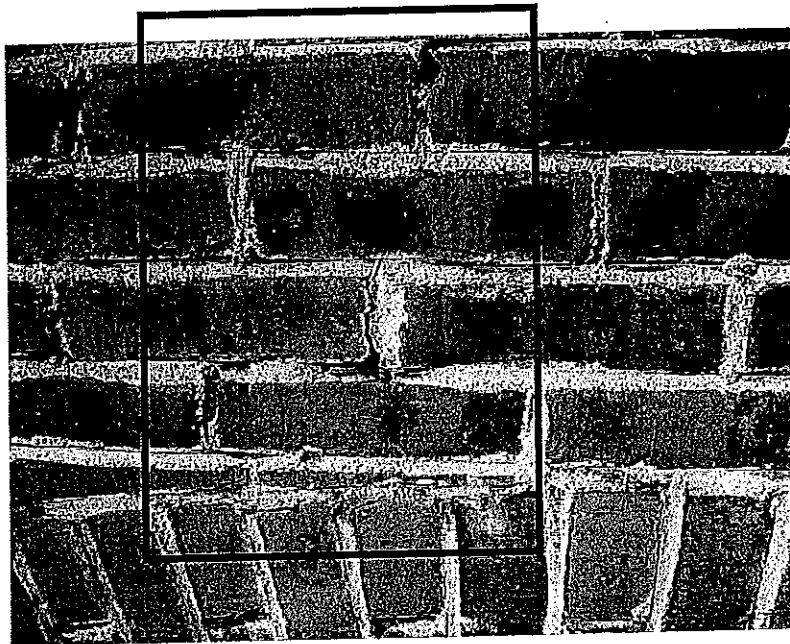
39. Photo 39 – View of the step crack in the mortar joint at a location that appears to have been previously repaired. This location is between the two windows in the easternmost bay of the South elevation.

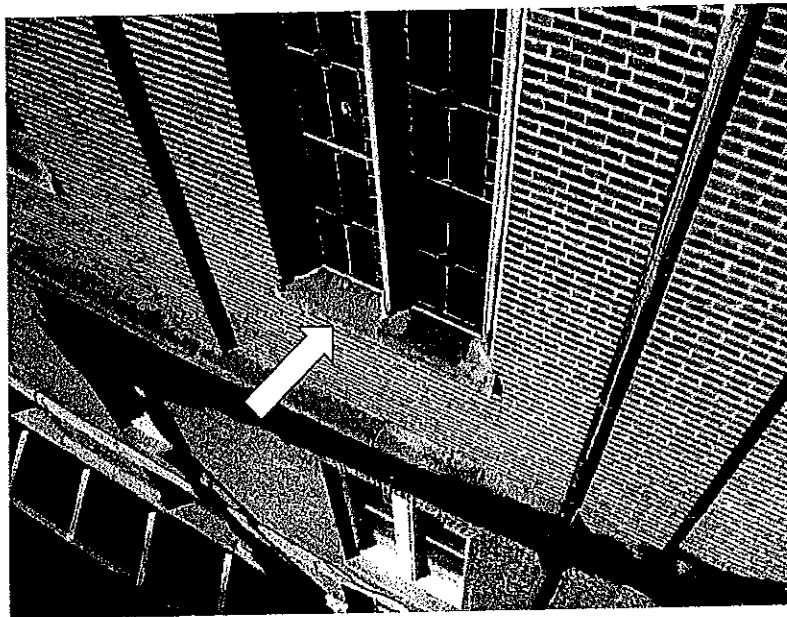
41. Photo 41 – View of the copper flashing over a stone window sill on the South elevation.

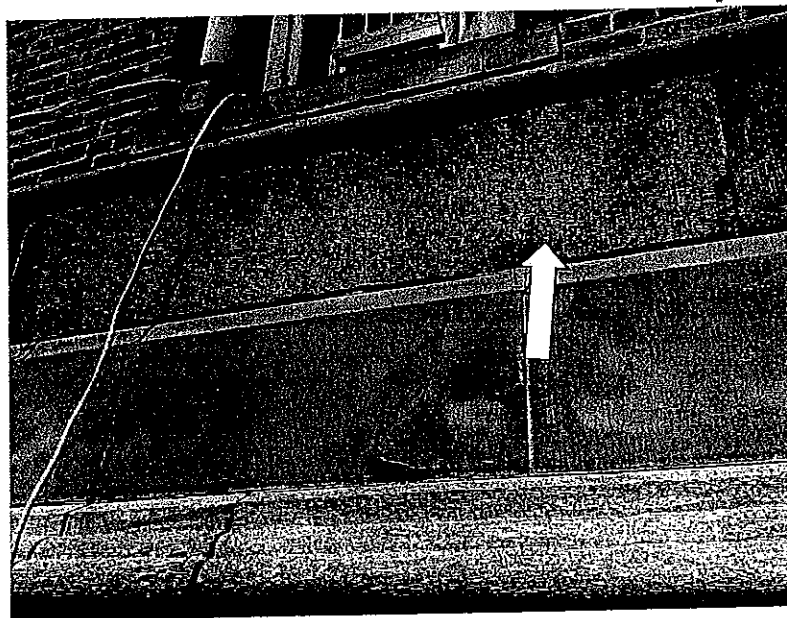
51. Photo 51 – View of the delaminated stone banding above the granite base on the Tower South elevation.

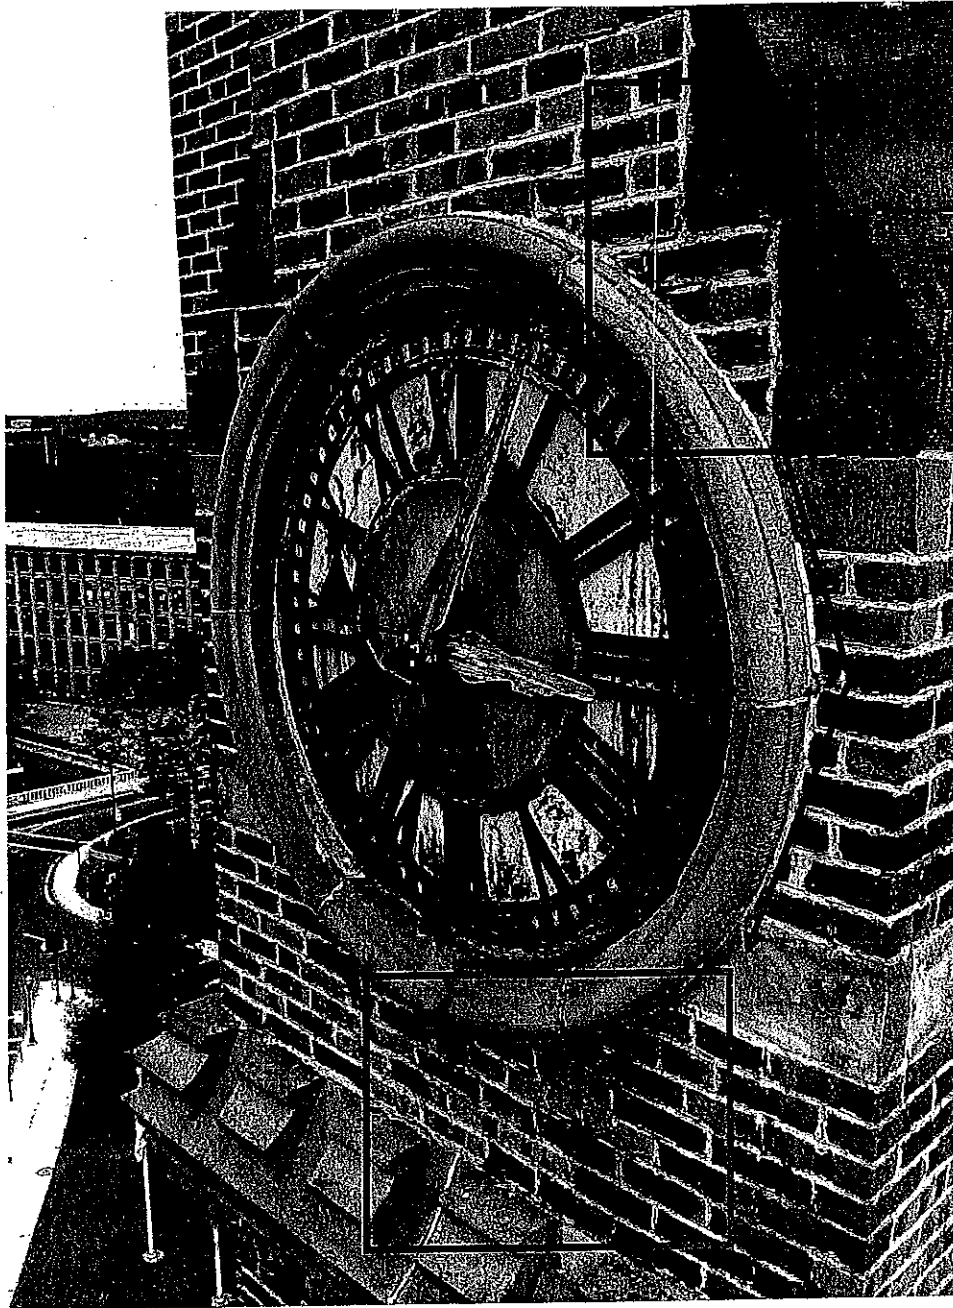
54. Photo 54 – Overall view of the South Tower clock and surrounding masonry components. The clock deficiencies are similar to those on the West elevation. Below the clock, stone banding exhibited deterioration including flaking, weathering, deteriorated mortar joints, and surface crusting. Step cracks were observed below the clock that appears to continue on the outside faces of the stone surround and connect to step cracks in the brick above the clock and into the sloped amortisement stones on the right (East) side.

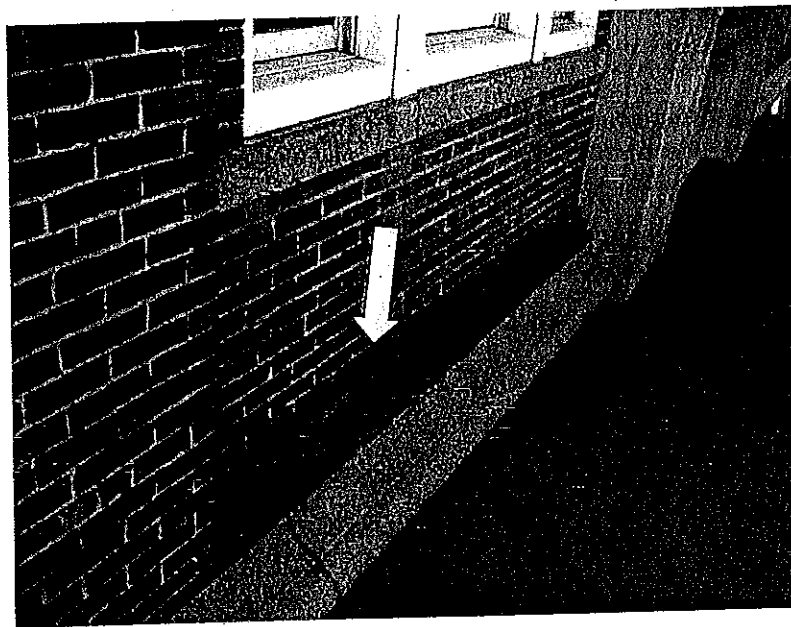
70. Photo 70 – View of the open mortar cross joints at the inward stepping brick above the main level water table on the Annex North elevation.

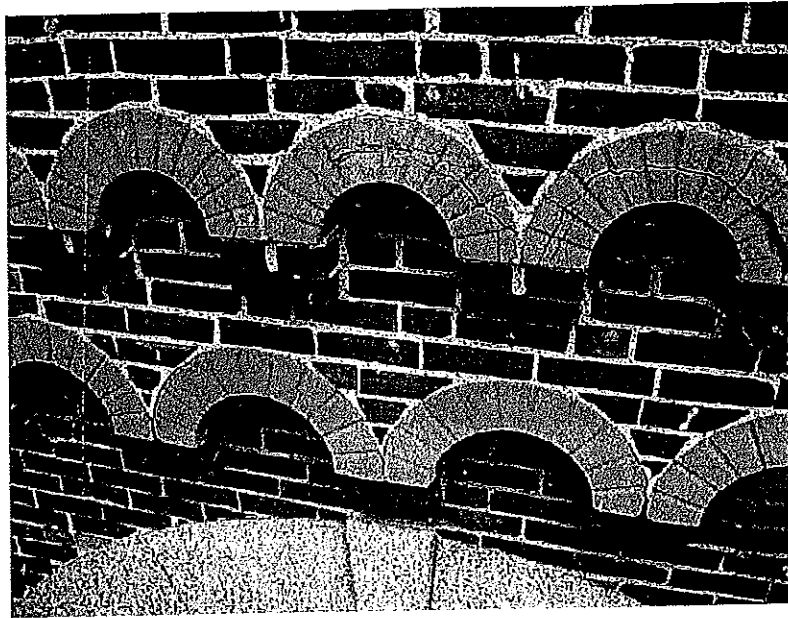
71. Photo 71 – View of the masonry arches on the Northwest elevation of the Annex between the fourth level windows and the copper cornice. Similar repairs were observed on the North and Northeast elevations. The masonry arches have cracked and spalled in some locations.

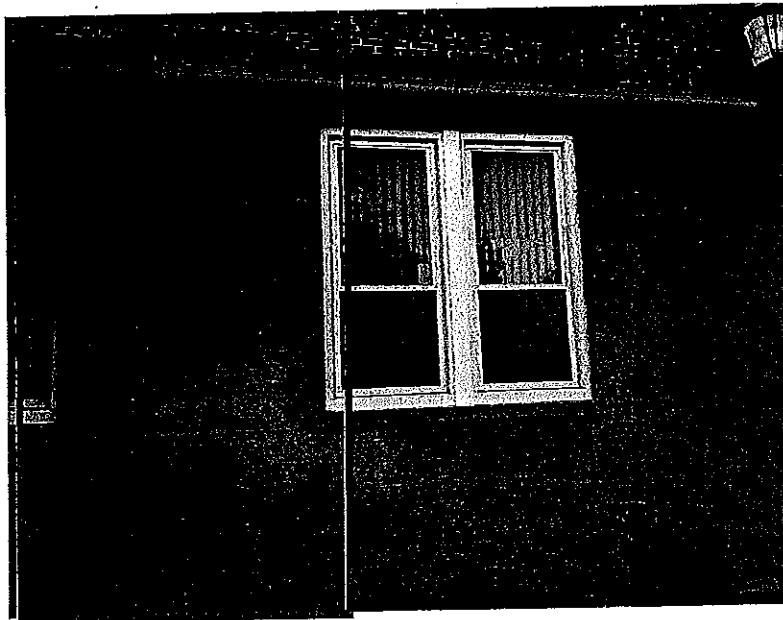
72. Photo 72 – View of the cast stone at the Annex North elevation, main level where the mortar joints between the windows are cracked.

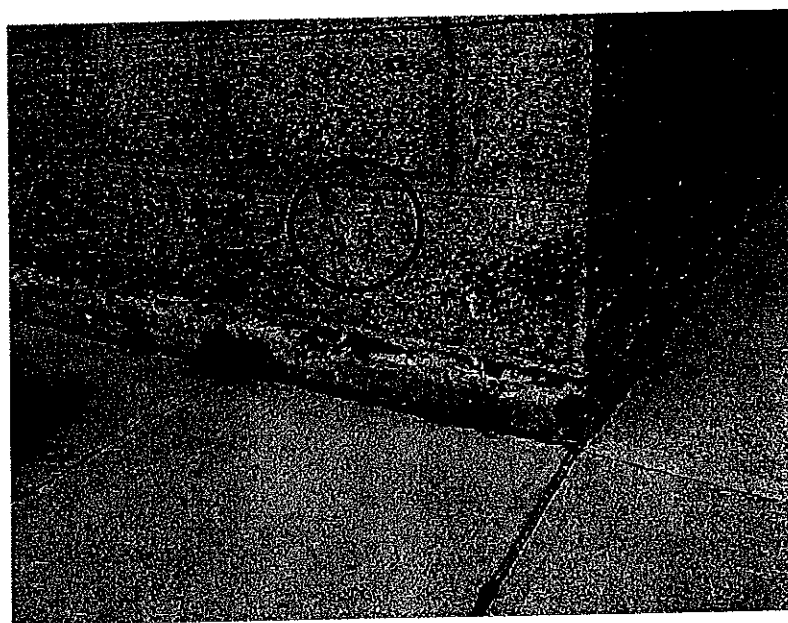
74. Photo 74 – View of the cracked and spalled stone where noted at the Northwest corner of the Annex. Also note the spalled concrete parge coat over the brick foundation.

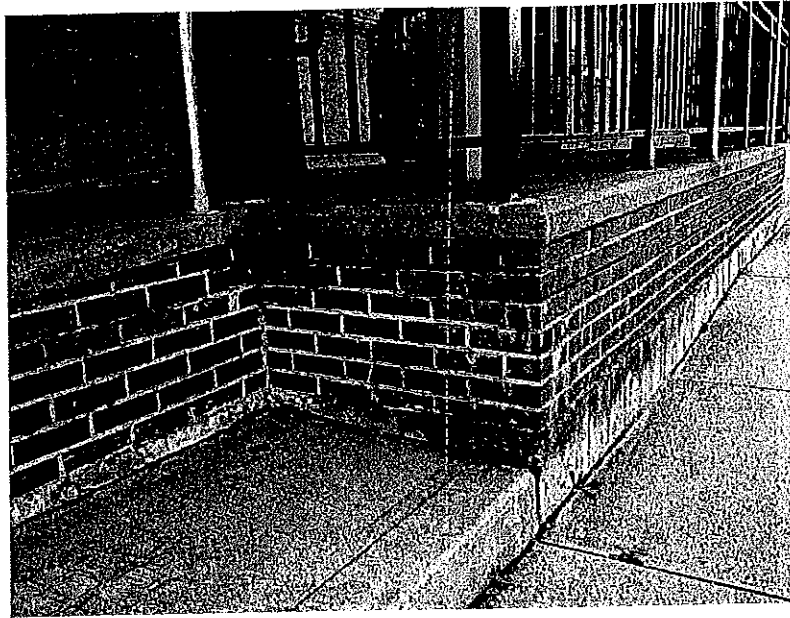
75. Photo 75 – View of the vegetative growth and efflorescence on the brick below the ramp on the Annex North elevation.

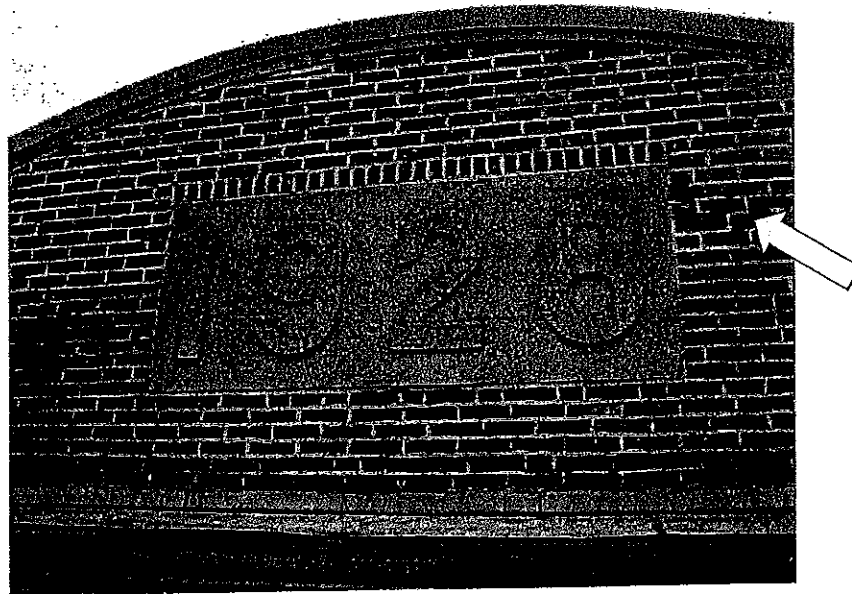
86. Photo 86 – View of the cast stone plaque set within the North Annex North original and rebuilt parapet. The rebuilt brick and mortar do not match the original construction. At the upper right corner, the new brick has started to crack and spall. The joint along the through-wall flashing and brick has been sealed, which will trap moisture within the parapet assembly.

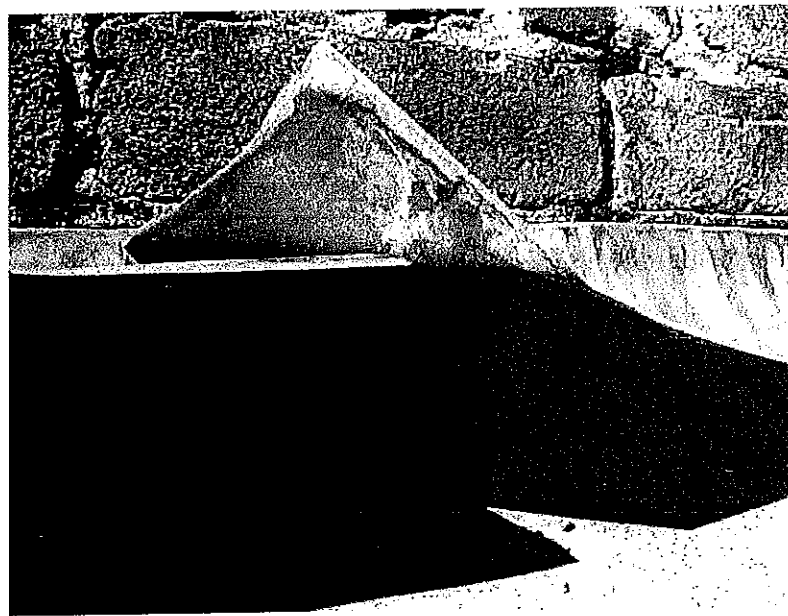
88. Photo 88 – View of the loose counter-flashing along the East elevation parapet. The loose flashing is subject to wind and weather infiltration behind the assembly. At this and other similar locations, the coping flashing was not secured to the brick.

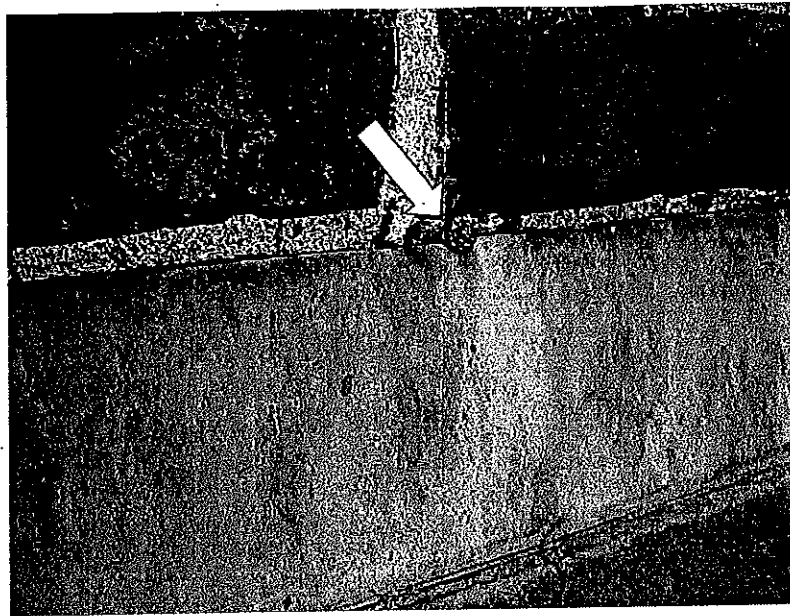
91. Photo 91 -- View of the Annex parapet flashing and the steel nail embedded in the mortar joint above the flashing. This was observed on each elevation except the North, which may have been removed or embedded into the sealant. The mortar joint between the flashing and the brick has cracked and spalled in many locations around the building.

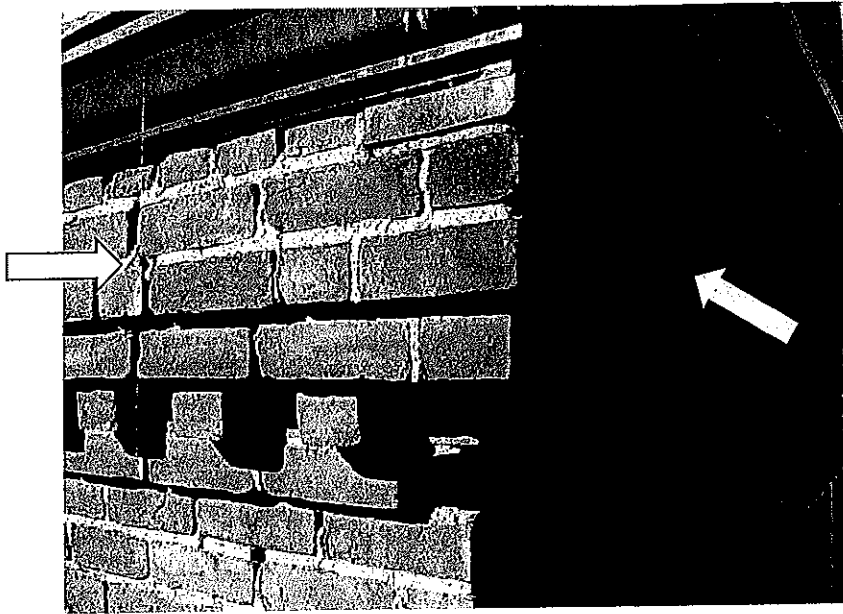
95. Photo 95 – View of the Southeast corner of the Annex two story wing. The projected brick above the corbels and dentils has a step crack on both the East and South elevations.

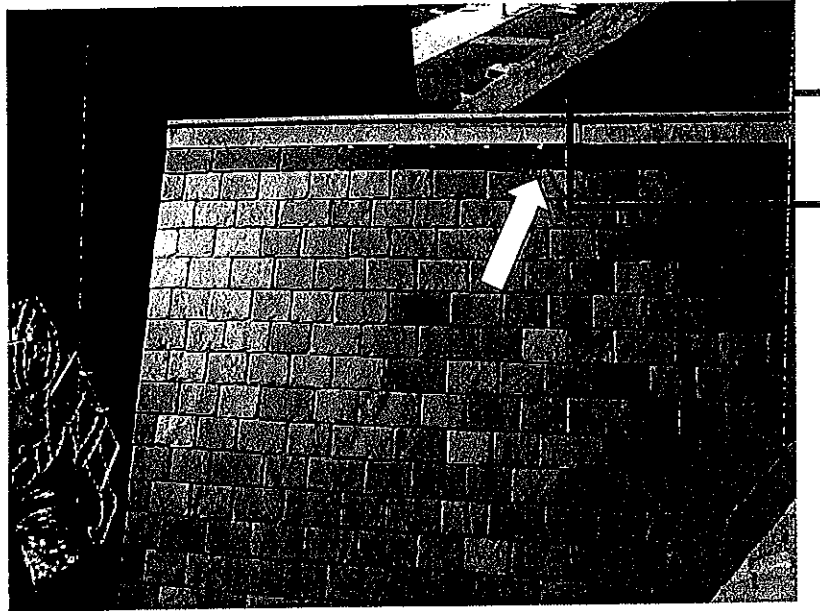
103. Photo 103 – View of the South gable roof. The loose slate abutting the ridge are denoted with the arrow and the slate with the missing Dutchmen nail flashing straps are captured in the rectangle. Both of these same condition were observed along the main roof ridge, the North gable roof, and the Tower gable roof.

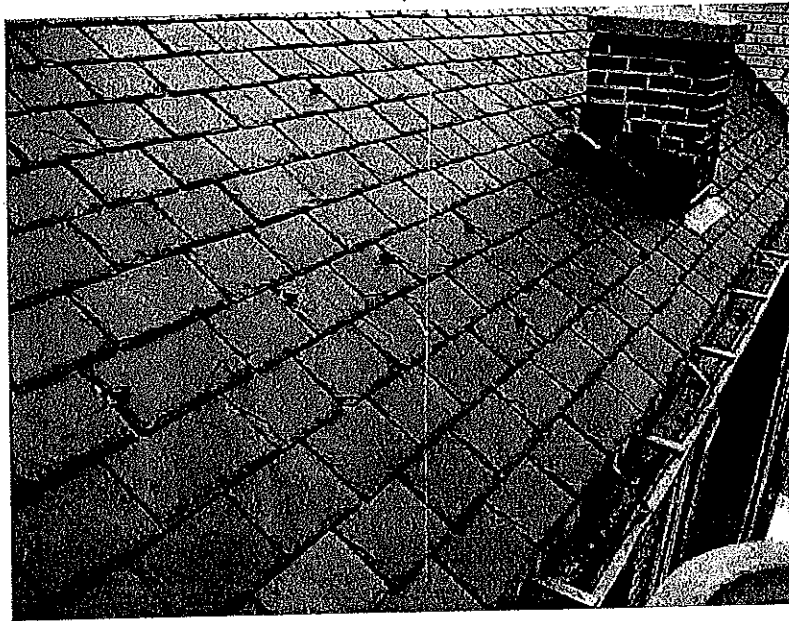
105. Photo 105 – View of a significant number of either missing or damaged pad style snow guards along the eave of the North elevation roof. Also note the amount of slate debris and broken snow guards in the gutter.

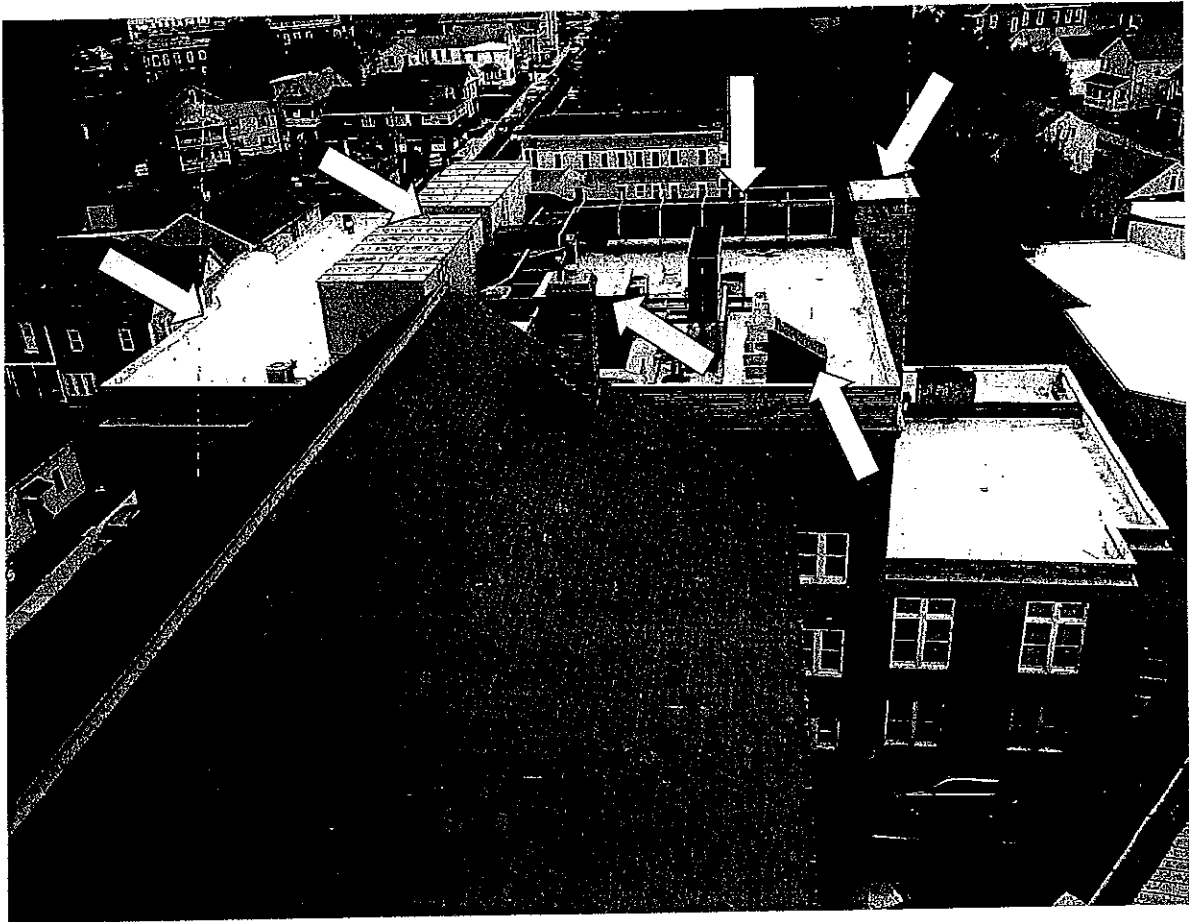
110. Photo 110 – View of the Old City Hall roof in the foreground and the white thermoplastic roof on the Annex in the background. A few items of note. First the elevated ducts are wrapped in black elastomeric (EPDM) roof membrane. Second, the roof top units have a standing seam metal roof. Third, the inside face of the parapets are wrapped with the thermoplastic roof membrane. The roofs for the duct shaft and the elevator tower also have the thermoplastic roof membrane. The sloped roof is the asbestos shingle tile roof noted earlier in the report.

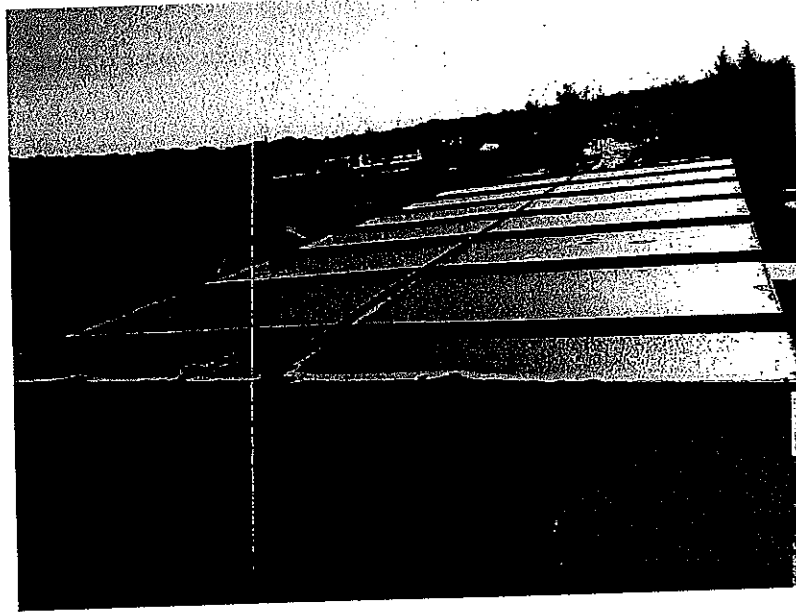
117. Photo 117 – View of the standing seam metal roof on the top of a roof top unit enclosure on the Annex high roof. At several locations, the paint has worn off exposing the metal to weather allowing it to rust.

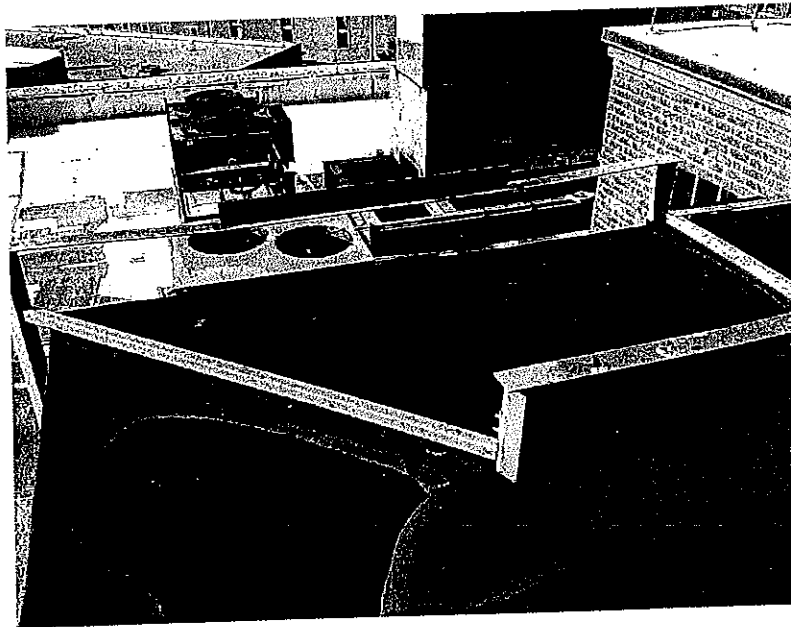
118. Photo 118 – View of the ponding water on the EPDM membrane around the elevated ducts on the Annex high roof.
